James Wallace House
8230 Brandywine Road
Cuyahoga Valley National Recreation Area
Northfield Center vicinity
Summit County
Ohio

HABS No. OH-2306

HISTORIC AMERICAN BUILDINGS SURVEY

JAMES WALLACE HOUSE

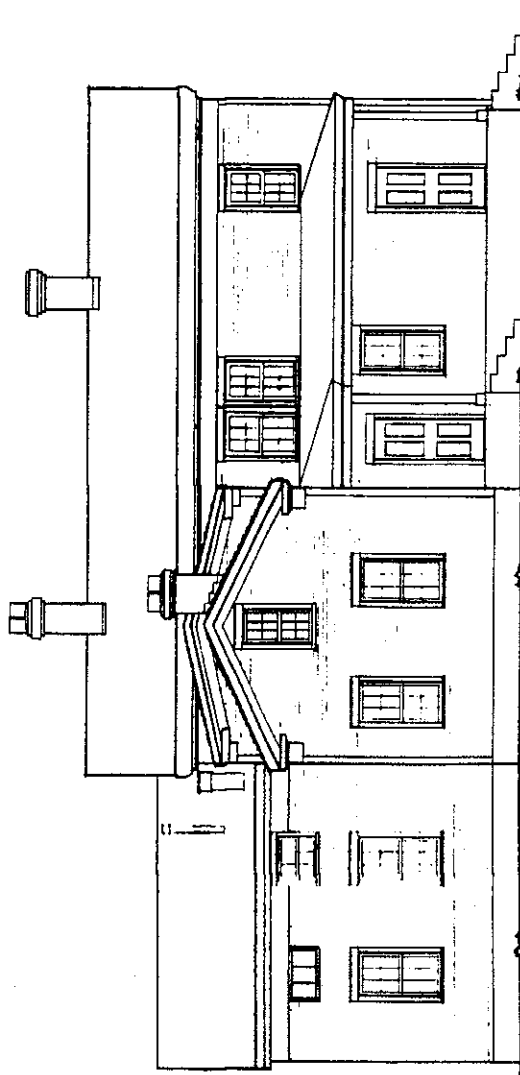
SOUTH ELEVATION

3. Framing: wood frame
 4. Porch: There is a large stone porch on the south side in the corner formed by the conjunction of the old wing and the circa 1850 portion. Large rectangular stone blocks are utilized for the foundation, steps, and floor. This style of porch is unusual for the Cuyahoga Valley.
